Supplementary file

Investigation into the rock property and fracture propagation pattern during

Supercritical CO₂ pre-fracturing in the conglomerate reservoir

Appendix A

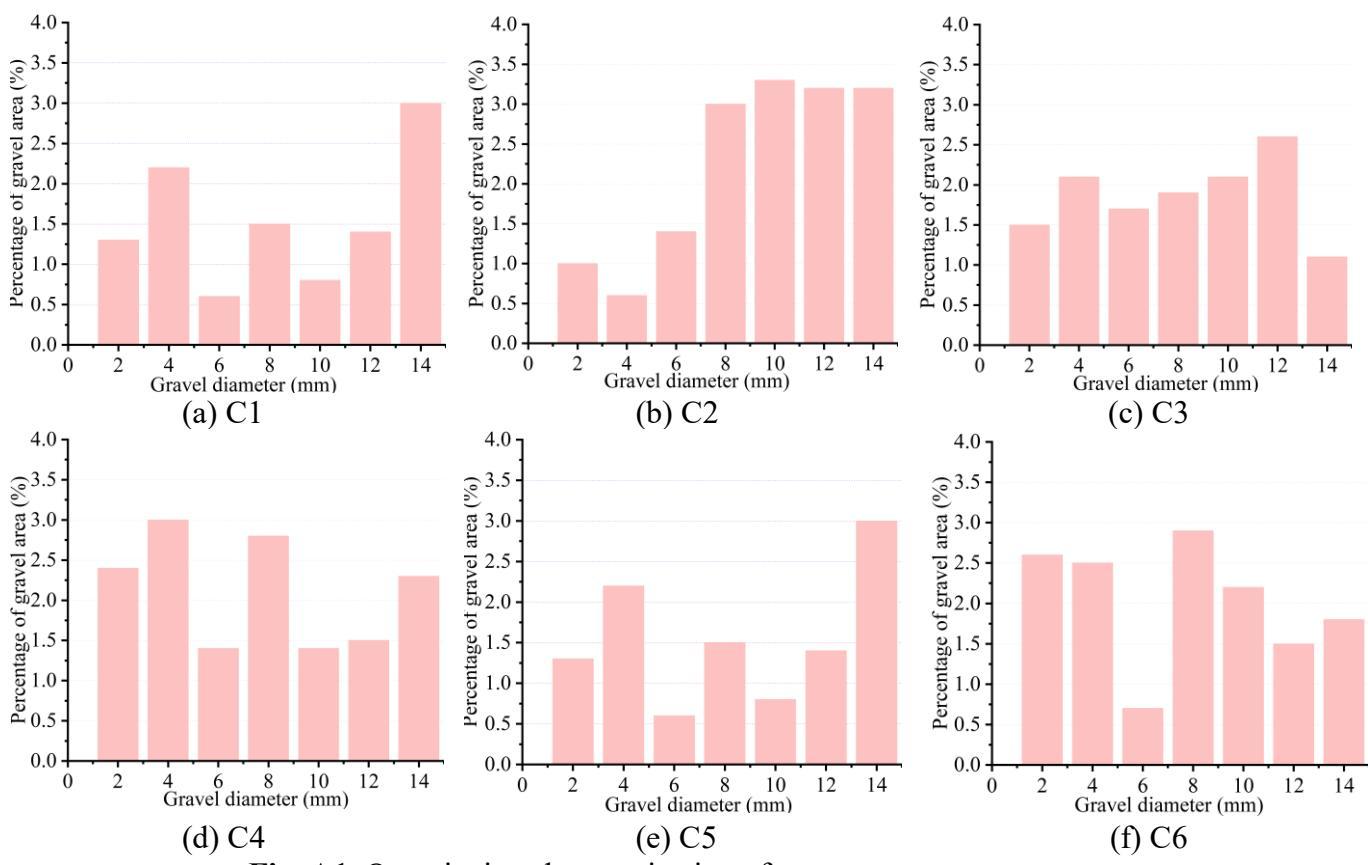
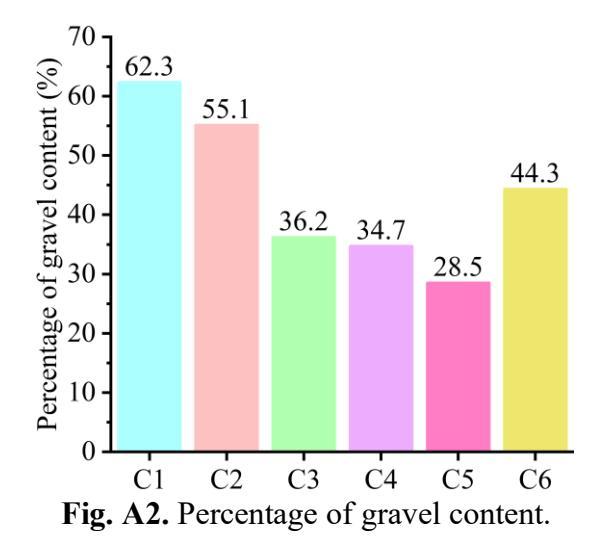
Fig. A1. Quantitative characterization of core component parameters.

Based on high-precision CT scanning of core samples, 3D digital cores of conglomerates were reconstructed to characterize the internal structural features of conglomerate cores (gravel content and particle size parameters). Gravel in conglomerates was extracted through threshold segmentation, gravel identification, smoothing, and integral calculation to quantify gravel content and particle size distribution (Orrú et al., 2014; Soloy et al., 2020), as shown in Fig. A2. The gravel content exceeds 50%, with gravel sizes ranging between 8 and 14 mm in particle-supported conglomerates (C1 and C2). The gravel content exceeds 35%, with gravel sizes ranging between 2 and 14 mm in multi-size particle-supported conglomerates (C3, C4, and C6). The gravel content is below 30%, with gravel sizes ranging between 2 and 14 mm in matrix-particle-supported conglomerates (C5).

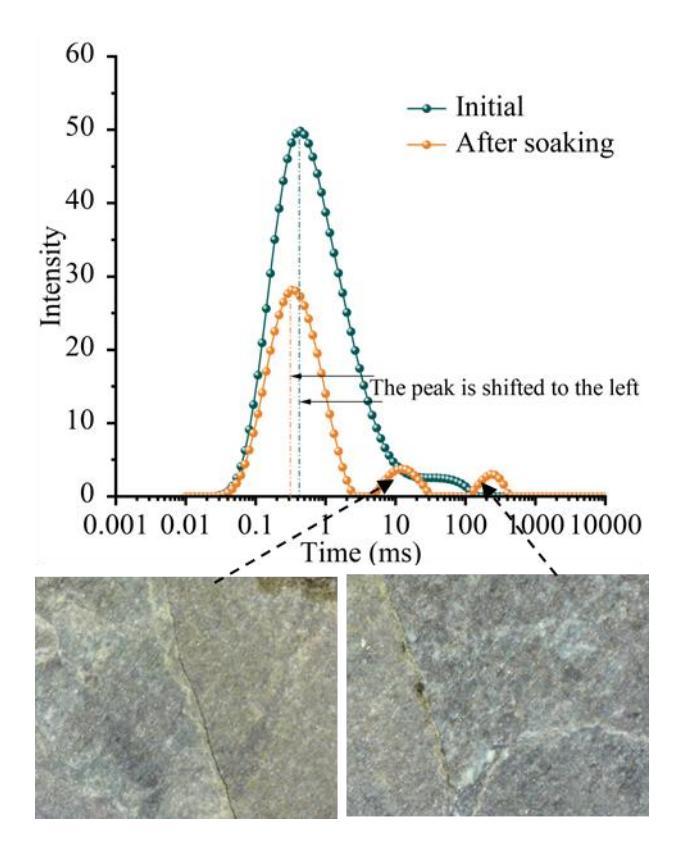
Fig. B1. Test results of C1-2 samples before and after soaking.

The surface morphology and NMR T₂ spectra of various conglomerate types before and after CO₂ soaking are illustrated in Figs. B1-B3. Observations of the core surfaces before and after soaking indicate that intense CO₂ diffusion induces dissolution of the cementation interfaces among gravels (C1-2), the matrix in fine-grained, gravel-rich zones (C4-2, C5-2), and the matrix in C6-2. This process gives rise to the formation of dissolution pores and microfractures. Simultaneously, the NMR T₂ spectra of the cores reveal that several small new peaks emerge on the right side of the spectrum after CO₂ soaking, indicating the in-situ formation of numerous dissolution pores and microfractures within the core. These dissolution features are principal channels for fracturing fluid leak-off during subsequent hydraulic fracturing. The injected fracturing fluid can rapidly migrate through these preferential flow pathways to deeper rock strata, significantly enhancing the penetration depth of artificial fractures. This further demonstrates that the fractures formed by dissolution during soaking dictate subsequent hydraulic fractures' location and penetration depth.

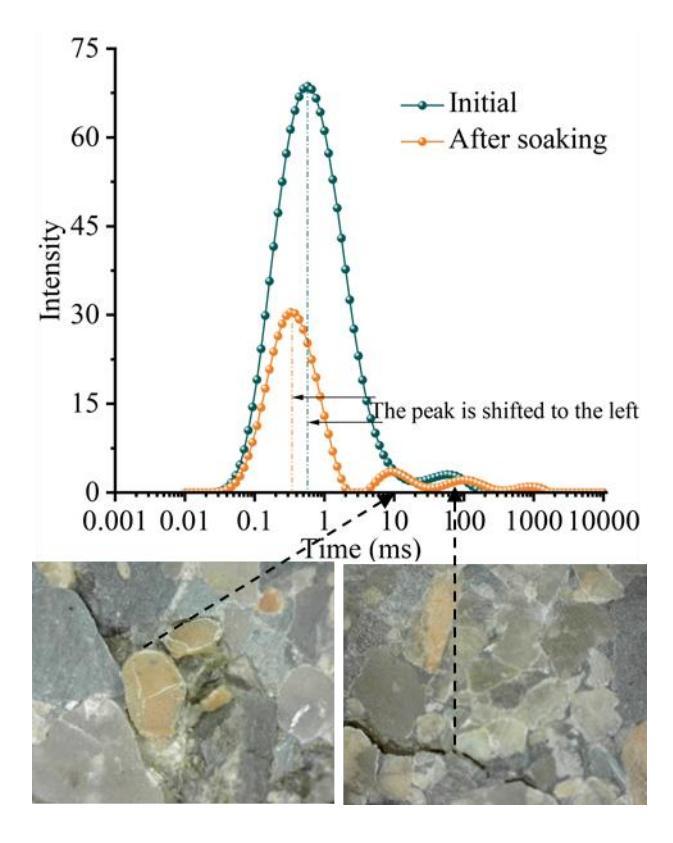
Fig. B2. Test results of C5-2 samples before and after soaking.

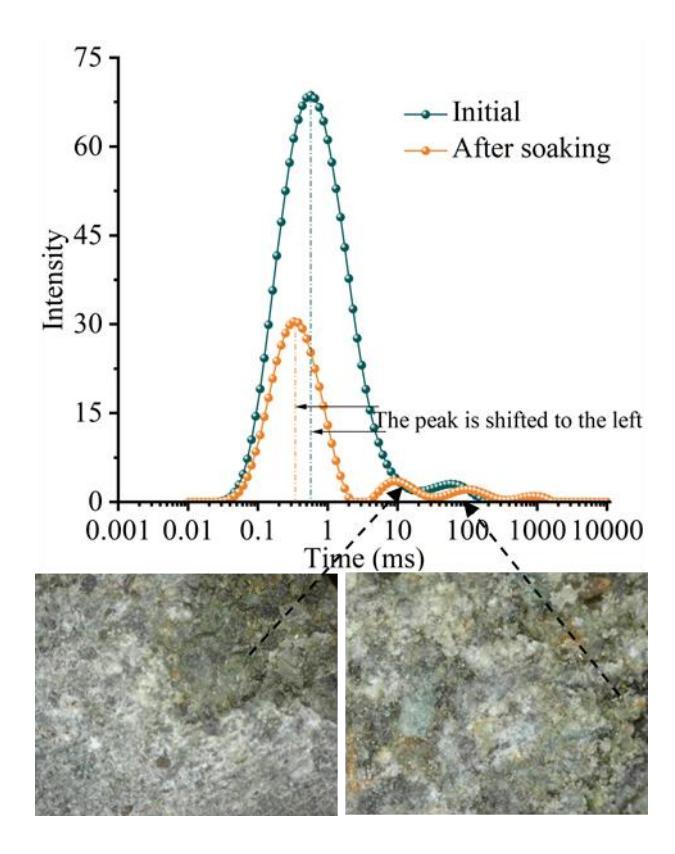
Fig. B3. Test results of C6-2 samples before and after soaking.
